# Tall Ship Stability

The art of not to capsize

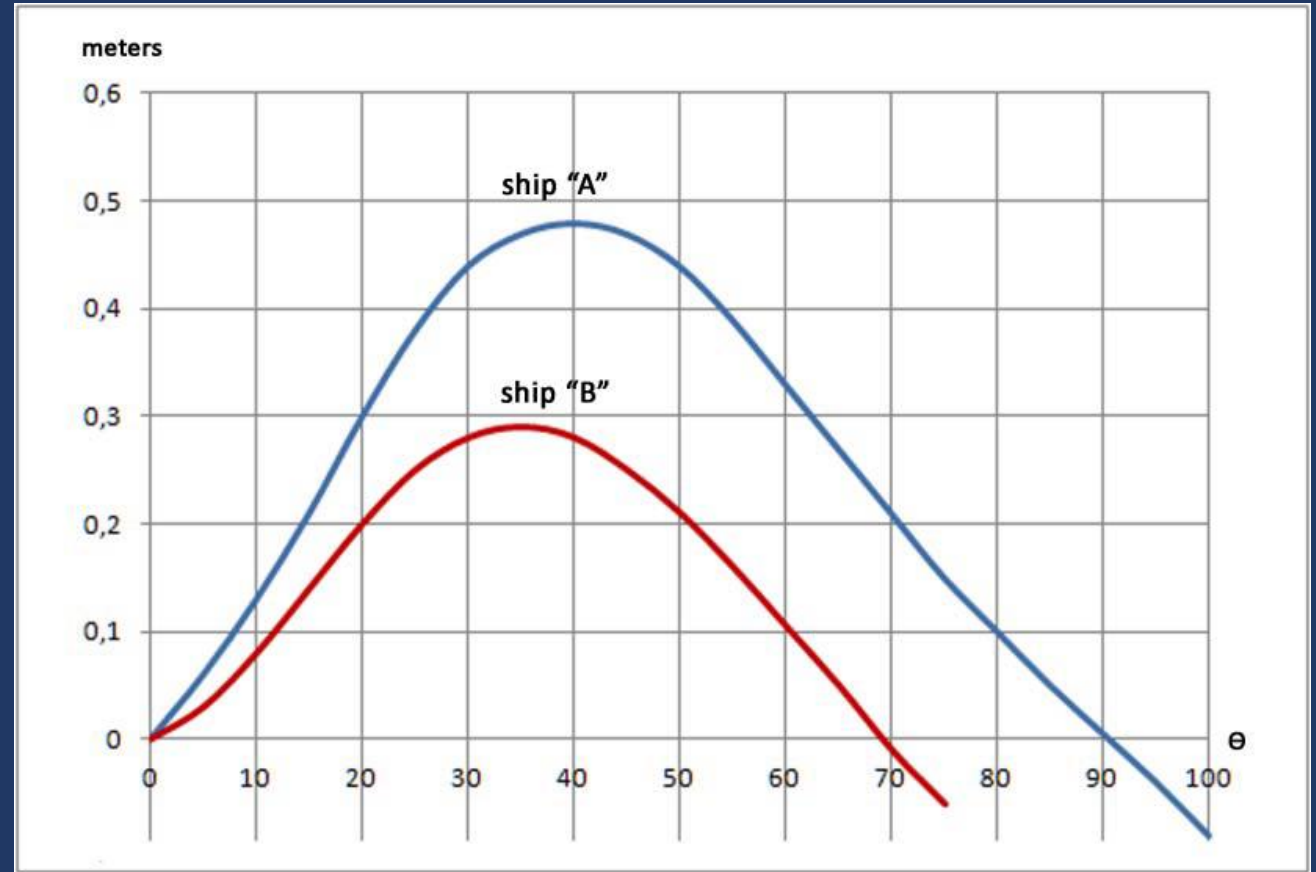
$$GZ = KN - (KG \times \sin \Theta)$$

Characteristic graphic of each ship is laid down in ship's papers.
